ANALYSIS of Existing International Methodologies and Best Practices for Monitoring Debris Flow Hazards and High-Mountain Lake Outburst Events

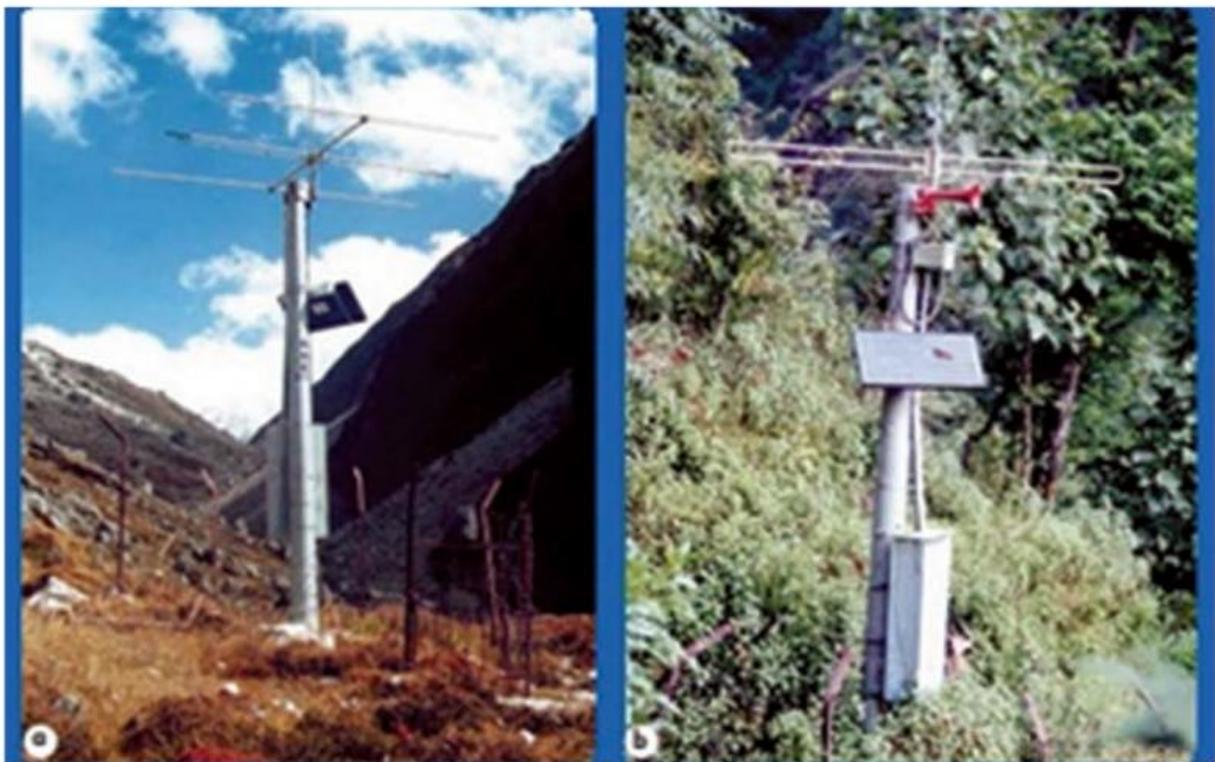
Figure 1. Early Warning System for Debris Flows in the Tamakoshi Valley: a – Lake Breach Detection Station; b – Debris Flow Warning Station with Siren.

The debris flow detection system comprises six water-level sensors installed along the riverbank immediately downstream of the lake to detect a breach. Three sensors are connected via armored and shielded cables to two independent transmitting stations, located 80 meters above the sensors for safety. The sensors are positioned at different heights, enabling the identification of water rise stages. The sensor network detects the lake breach immediately and transmits an alarm signal within two minutes. A remote station in Na village warns the local population of the threat.

The warning system includes 19 alert and relay stations in 17 villages across the Rolwaling and Tamakoshi Valleys (see Figure 1). Warning stations are mounted on 4.67-meter masts, with antennas extending to 5 meters above ground. Lightning rods and solar panels are installed on the same mast. The transmitter and siren relay are housed in a metal box attached to the mast. Sirens operate on compressed air cylinders for two minutes, producing a sound of 80 decibels audible up to 150 meters, with backup electric sirens operating for four minutes. The system relies on line-of-sight radio technology, with signals relayed from station to station.

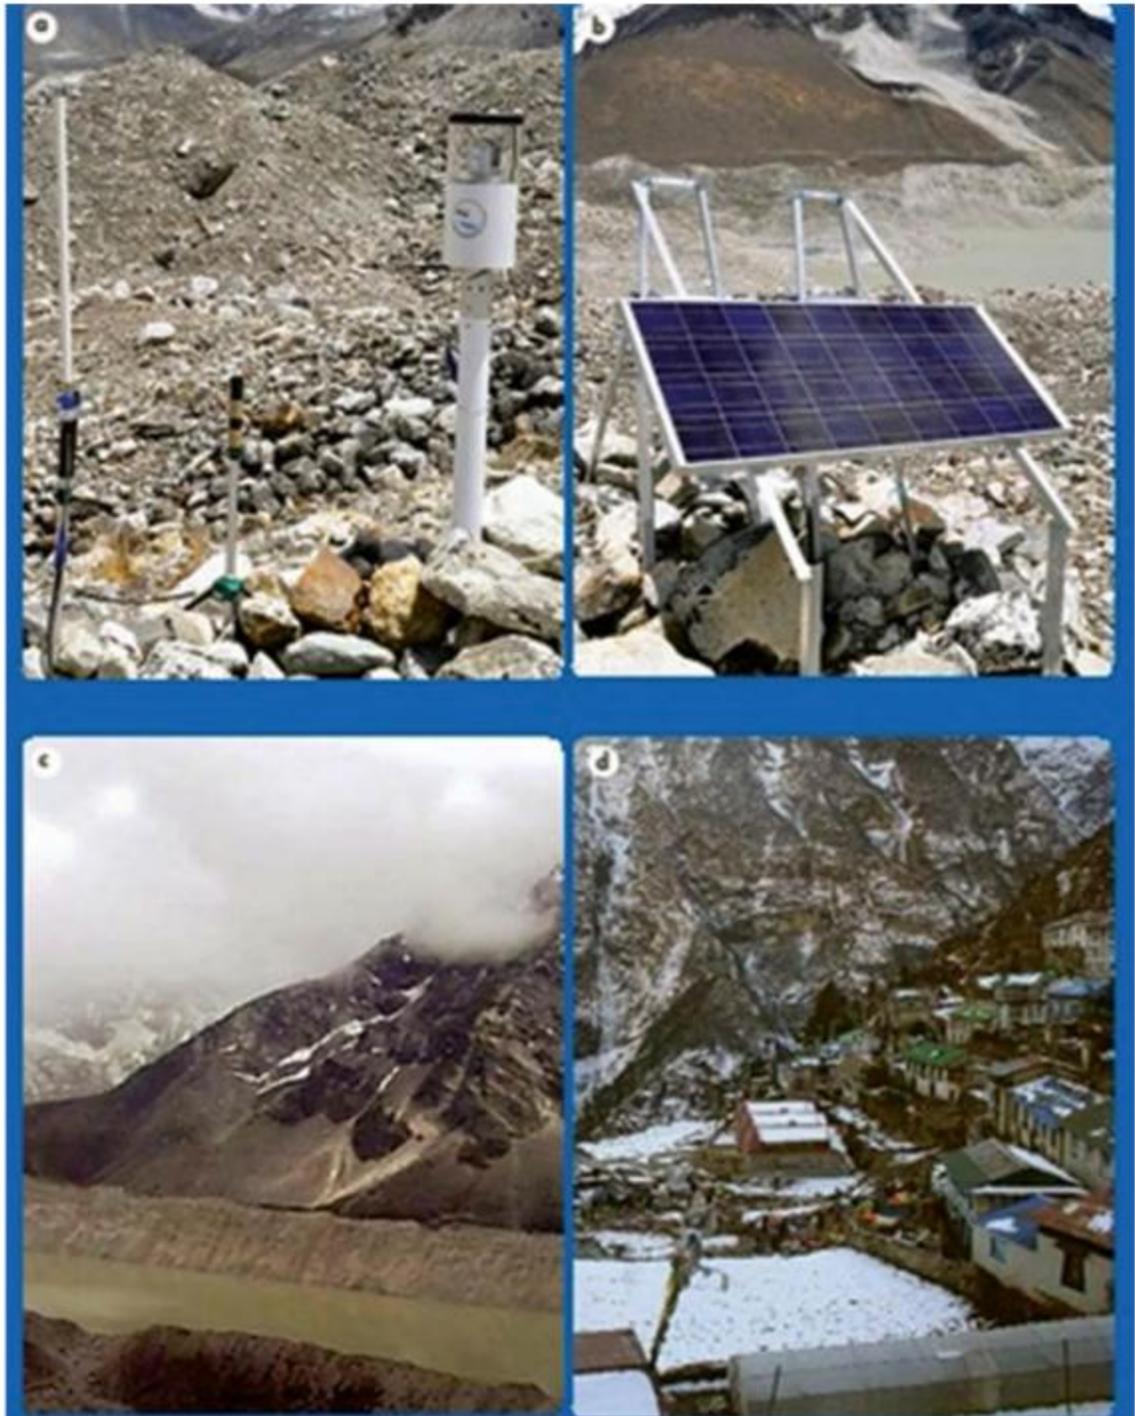
Figure 2. Monitoring System for Imja Lake: a – Upper field server at Imja Lake; b – Solar panel of the field server; c – View of the lake from the upper field server; d – View from the lower field server toward Namche Bazaar.

Monitoring of Imja Lake in the Everest Region, Nepal. Imja Lake is one of the fastest-growing lakes in the Himalayas. ICIMOD monitors the lake to develop an early warning system. A remote sensor system, employing geo-ICT tools and technologies, was developed in cooperation with the Department of National Parks and Keio University, Japan (Figure 2) [28].

Two observational devices, or field servers—Internet-enabled robotic systems for field monitoring—were installed on the lake shore at an elevation of 5,000 m and near the nearest

settlement, Namche Bazaar, in 2007. The field servers capture images of the lake and Namche Bazaar, as well as meteorological data, which are transmitted in real time via Wi-Fi to a server in Japan. The Department of Hydrology and Meteorology conducted outburst flood modeling using a dam breach model. Detailed hazard mapping and population risk assessments related to landslides and debris flows are also planned.

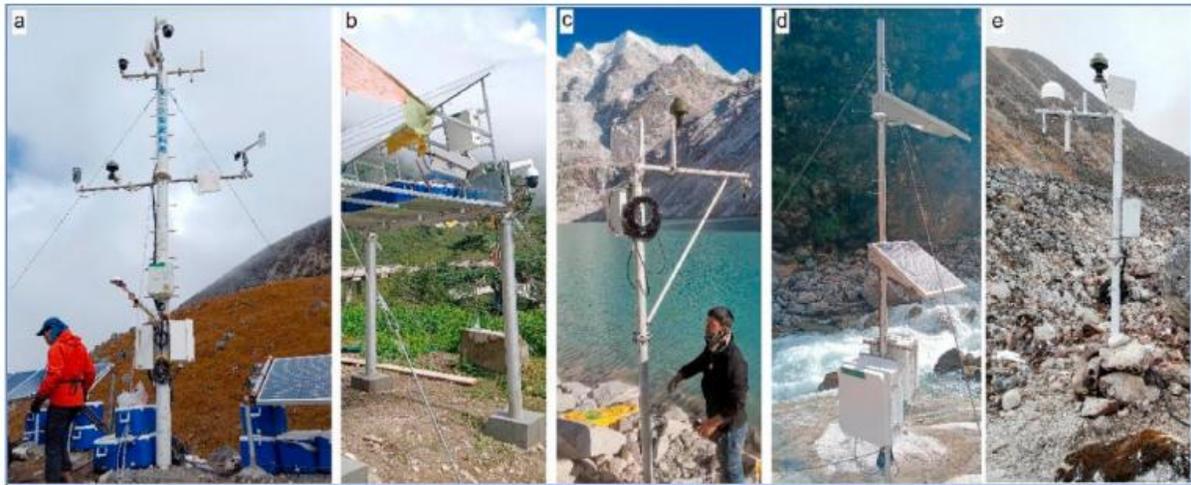
Figure 3. Early Warning System Installed at Cirenmaco Lake, Comprising: a – Monitoring of the lake and glacier; b – Monitoring of the surrounding environment and river; c – Monitoring of lake water level; d – Monitoring of river water level; e – Dynamic monitoring of the moraine dam.

An effective early warning and monitoring system has also been established for Cirenmaco Lake, situated at an elevation of 4,612 m in Tibet, near the China–Nepal border, within the Poigu River Basin (Figures 3 and 4).

Overall, the early warning system at Cirenmaco Lake encompasses monitoring of the lake, glacier, and outflowing river, including observation of water levels, the dynamic condition of the moraine dam, bathymetric monitoring, topographic mapping, data transmission, and early warning signal processing.

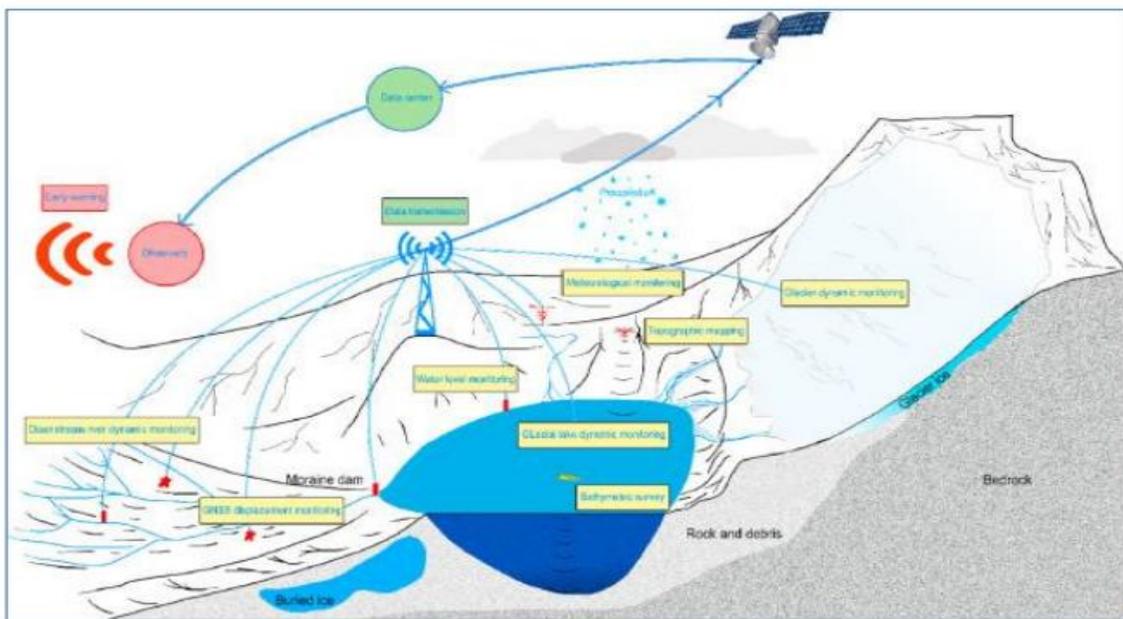
Figure 4. Diagram of the Main Components of the Early Warning System at Cirenmaco Lake.

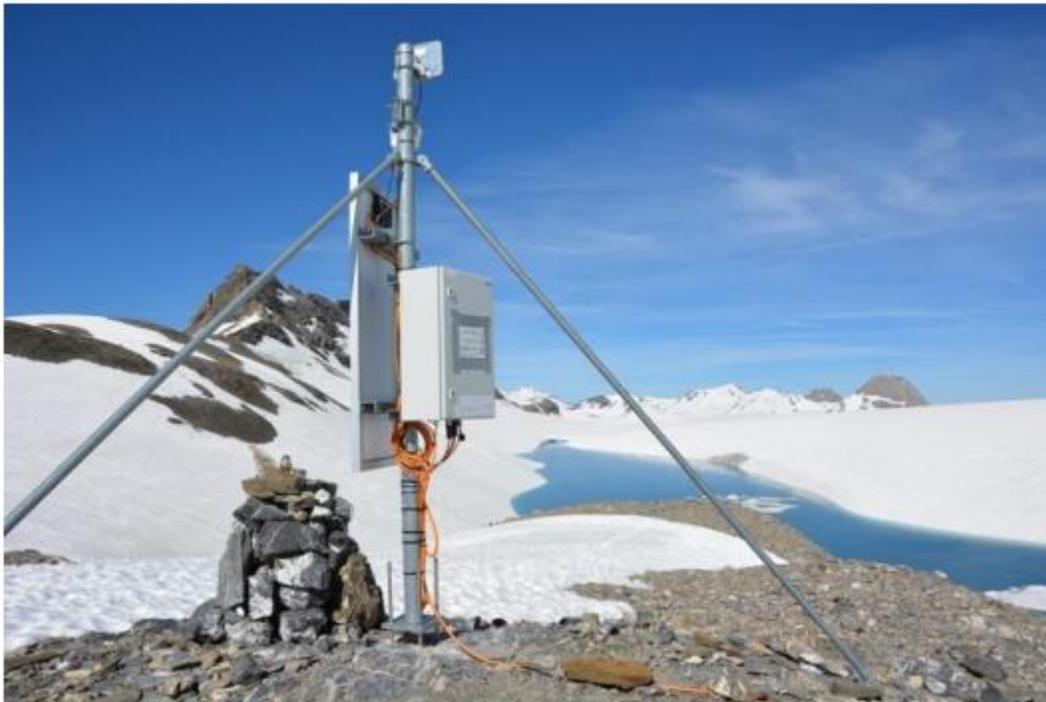
Figure 5. Automated Monitoring Station at a Glacial Lake (Bernese Alps, Switzerland).

The increasing frequency and severity of individual hydrological hazards in Switzerland prompted the development of a comprehensive information platform for natural hazards [32]. Its objective is to provide integrated, real-time, visually accessible safety information through warning centers (Figure 5).

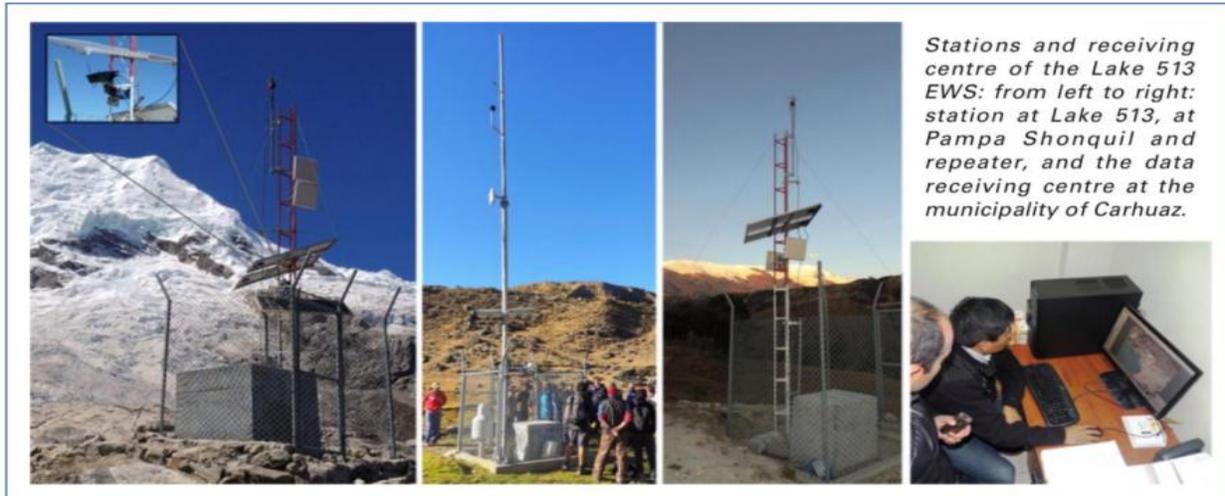
Figure 6. Monitoring station and transmission center at Lake No. 513 (Peru).

Automated early warning systems for moraine-dammed glacial lake outbursts are also applied in Peru. An example is the system established in the Santa River Basin at Lake No. 513, located at 4,428 m above sea level (Figure 6).
