Situation-Analytical Brief

Date of the brief: 28 July 2024

Issue: Potential outburst of Moraine Lake No. 5, Almaty Region

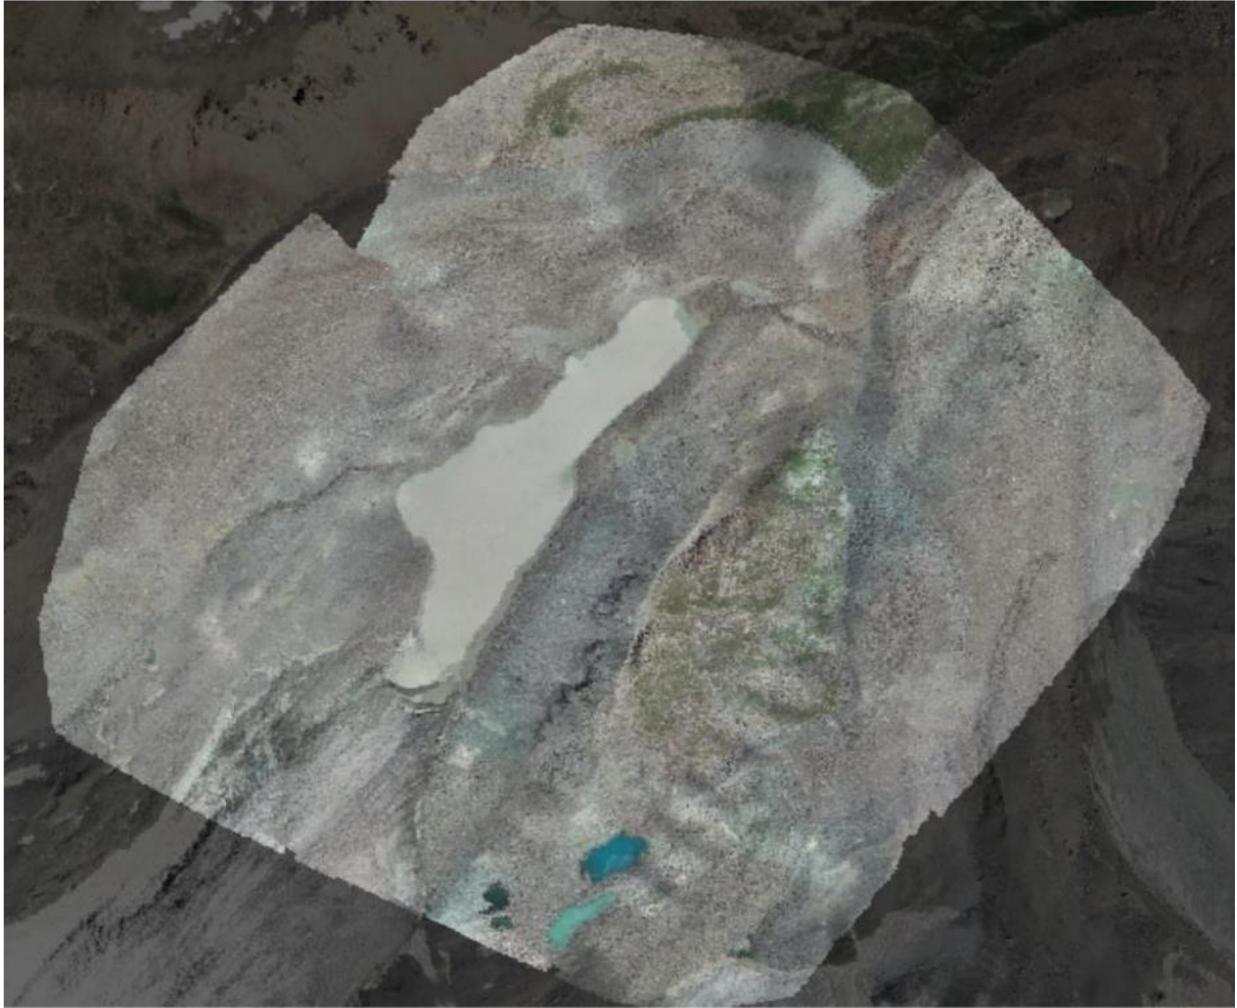
Orthophoto map of the area

Aerial surveying of the area over Moraine Lake No. 5 was conducted on 25 July 2024, covering a total area of 1,555 m².

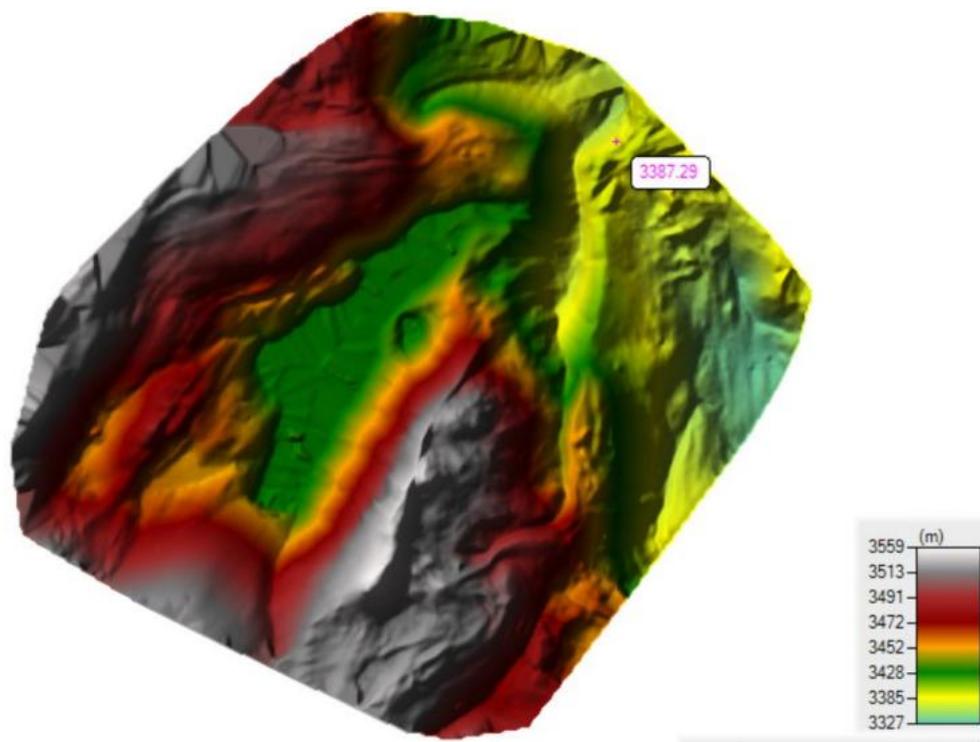
Digital terrain model of the area

The maximum elevation difference is 232 m, ranging from 3,327 m to 3,559 m.

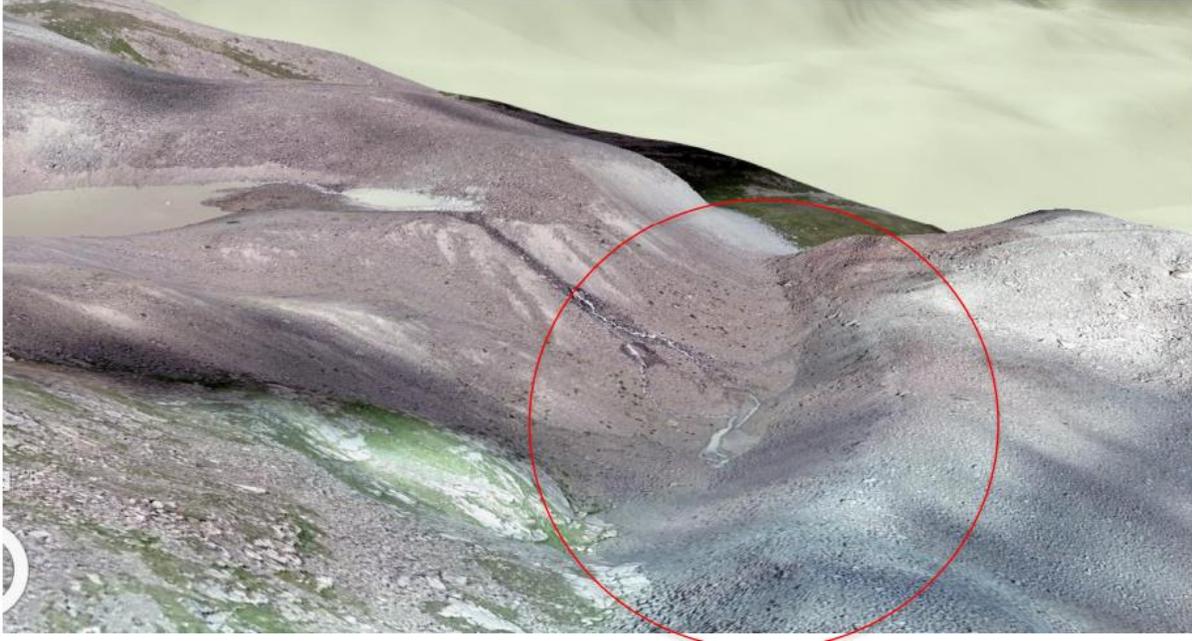
Enlarged view from northeast to southwest

The depression is currently not filled with water.

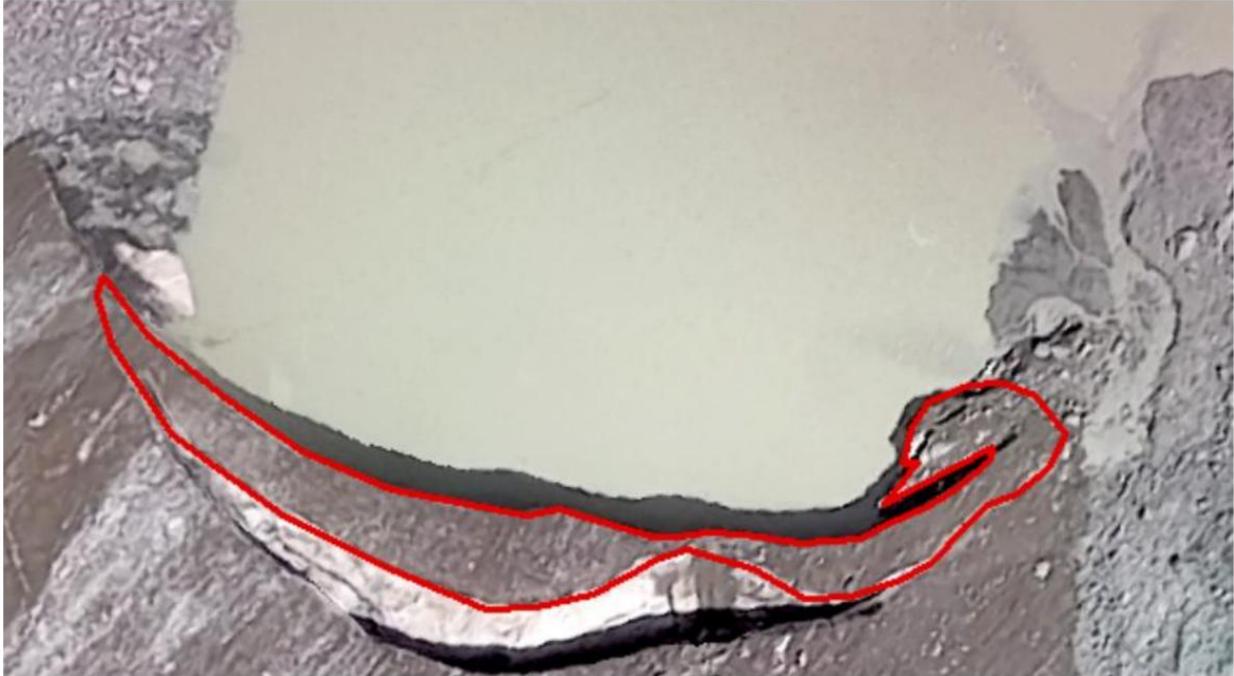
Calculation of the area of the overhanging section of the glacier

According to the orthophoto map obtained from the survey, the area of the overhanging section of the glacier at the time of the survey is **680.764 m²**.

Height, according to Kazselezashchita data, is **21 m**. Accordingly, the volume at the time of the survey is calculated as $680.764 \times 21 = \mathbf{14,296.044 \text{ m}^3}$. Considering ice density during melting, the equivalent water volume is **13,152.36 m³**.

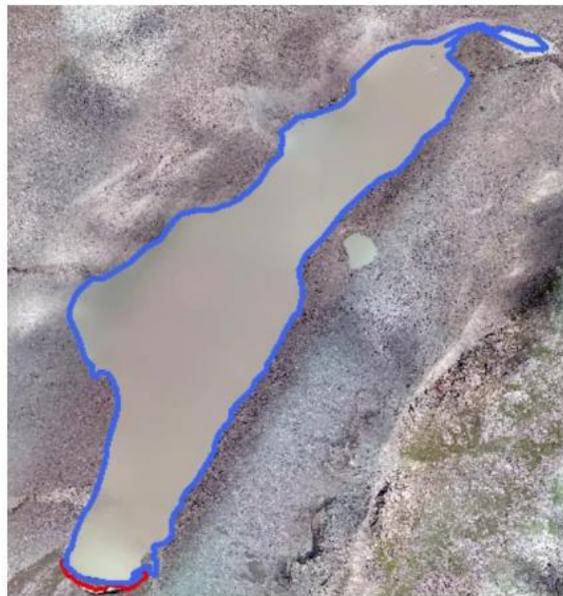
Calculation of the current water surface area

According to the orthophoto map obtained from the survey, the surface area of the lake is **95,194.5 m²**.

The volume, according to Kazselezashchita data, is **988,000 m³**.

Note: Potential inaccuracies may exist, as calculations were performed in the WGS-84 coordinate system.

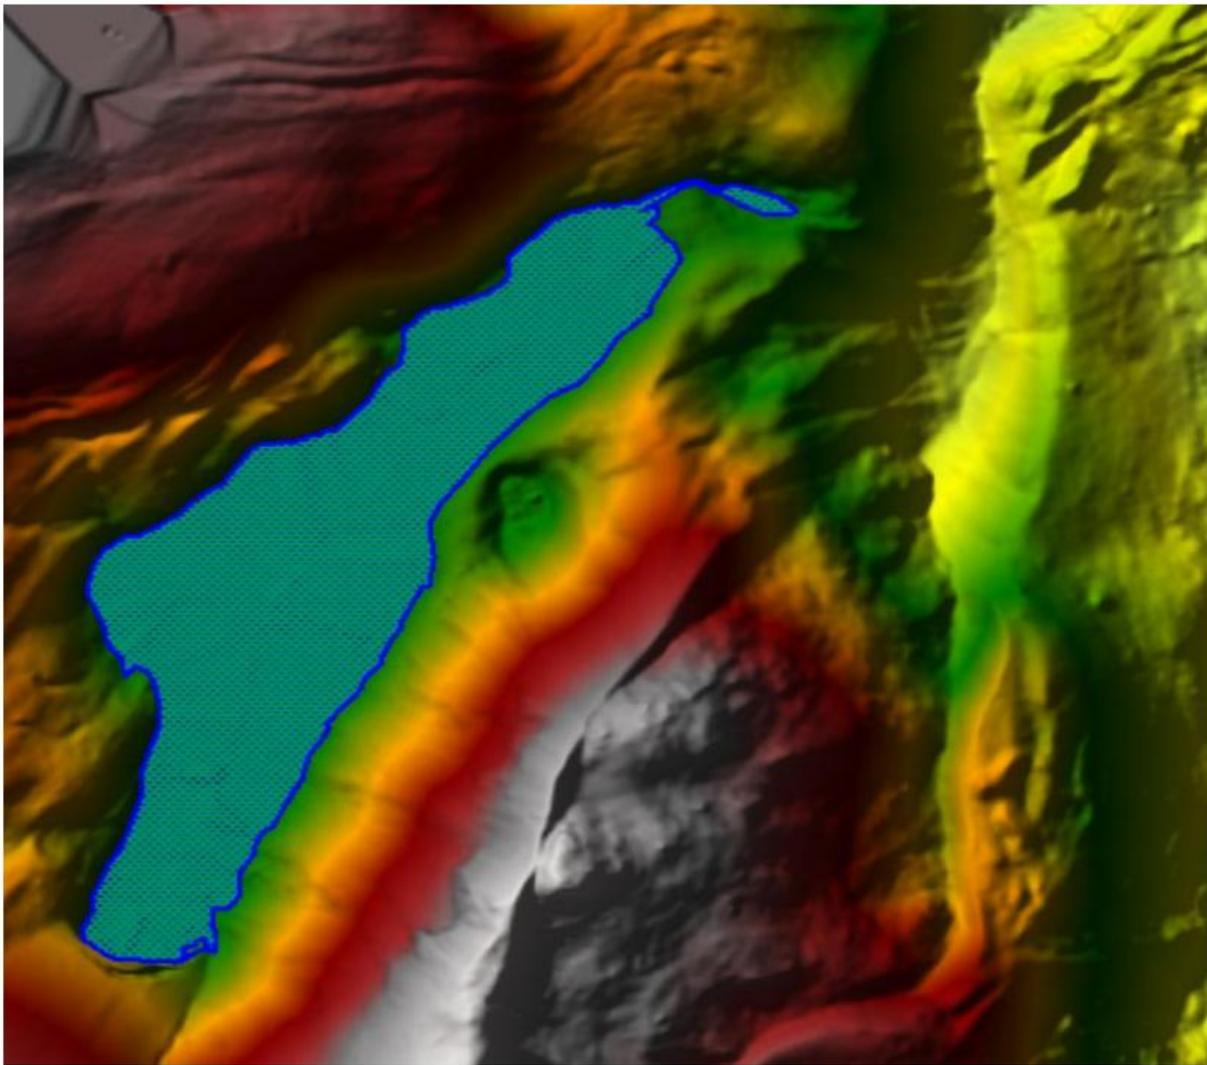
Current status

- Manning's roughness coefficient applied: 0.2 (for debris flows consisting of mud, stones, etc.; enclosed floodplains, fully forested, taiga-type; basin slopes in natural condition).
- Hydrograph volume: **20,000 m³**.

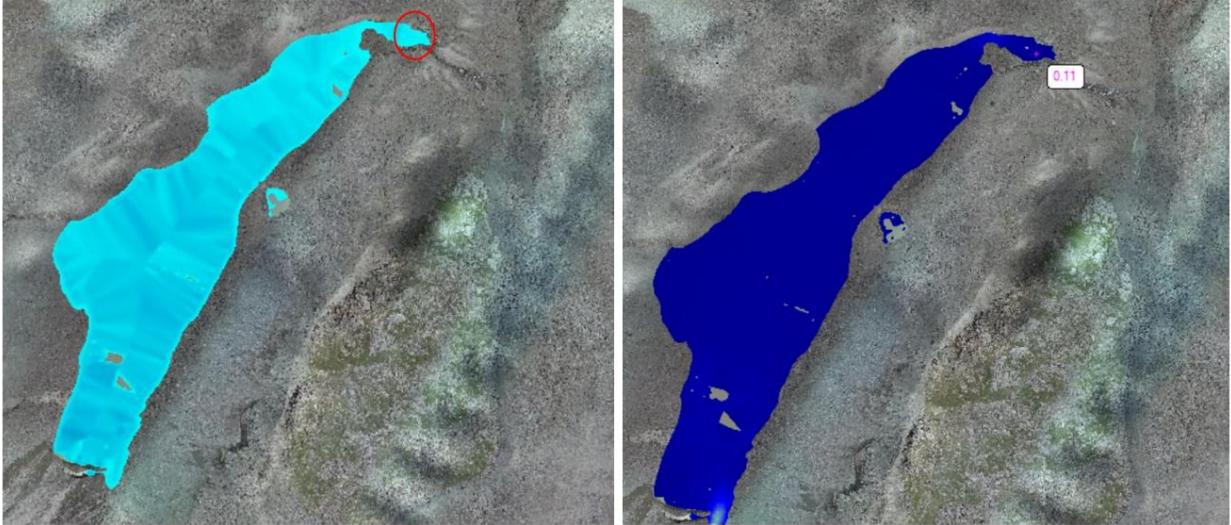
At the current moment, the flow velocity is 0.11 m/s with a depth of 1 m

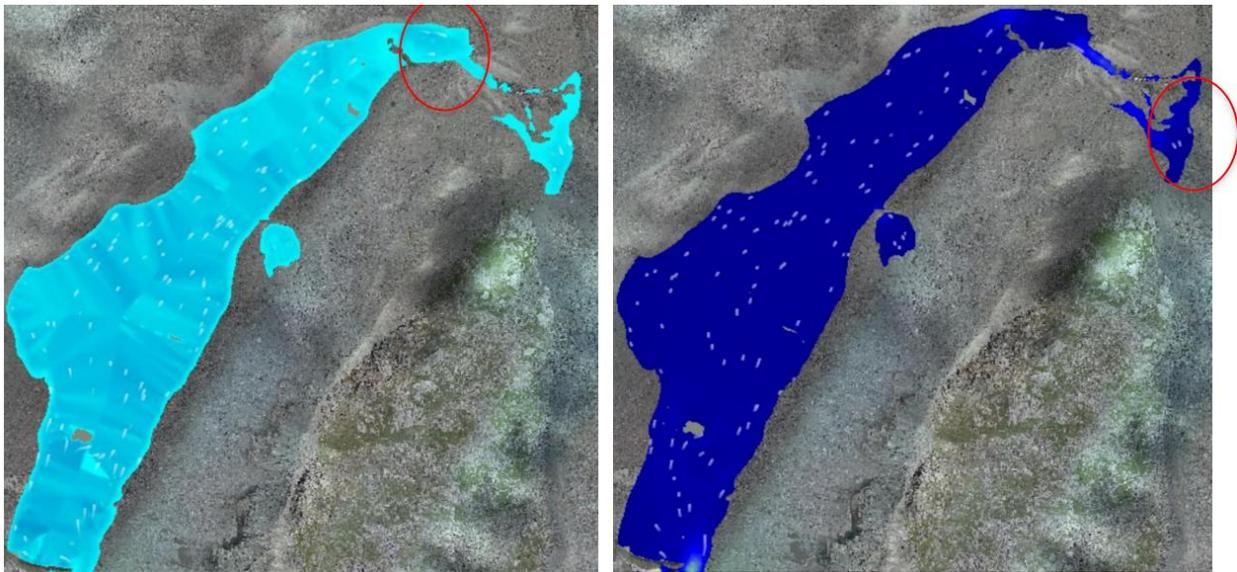
After 10 minutes:

- 1) The basin will fill completely, with part of the water overflowing into the depression.*

Flow velocity in the depression: 0.18 m/s with a head difference of 25 m.

Flow velocity in the original pond: 0.4 m/s with a depth of 4 m.

Depression area: 4,971.28 m², average depth: 1.5 m, volume: 7,456.92 m³.

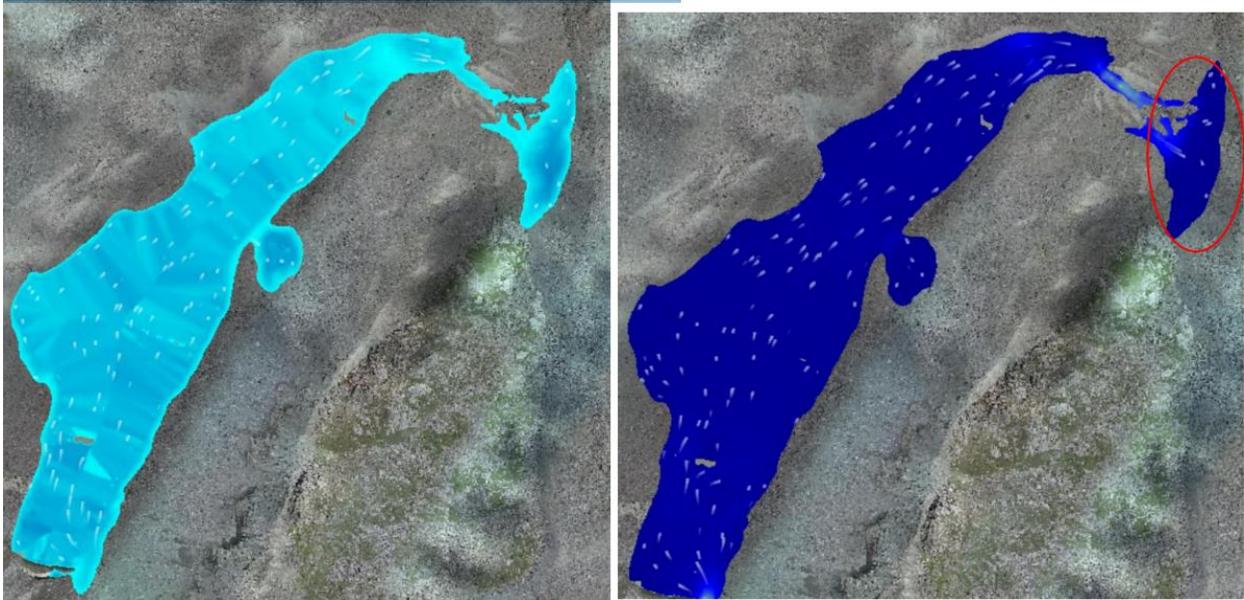
After 20 minutes:

- 2) The depression and the lake will continue to fill.*

Flow velocity: 0.1 m/s with a head difference of 29 m; average depth in the depression: 2 m.

Total water surface area: 129,471.85 m².

Depression area: 10,025.25 m², average depth: 2 m, volume: 20,050.5 m³.

This volume of the depression, excluding the lake, exceeds the volume of the overhanging glacier section; therefore, the glacier does not pose a threat.

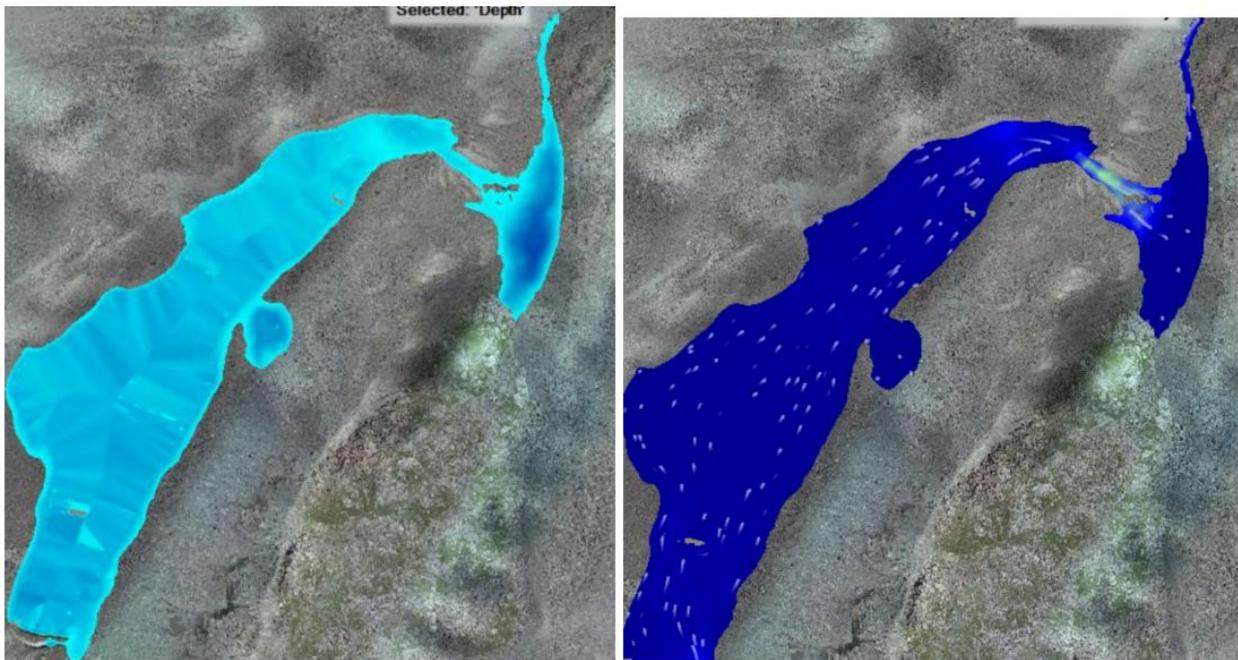
After 30 minutes:

- 3) The depression will fill, and part of the water will flow downstream toward the river channel.

Inflow velocity into the depression: 2 m/s.

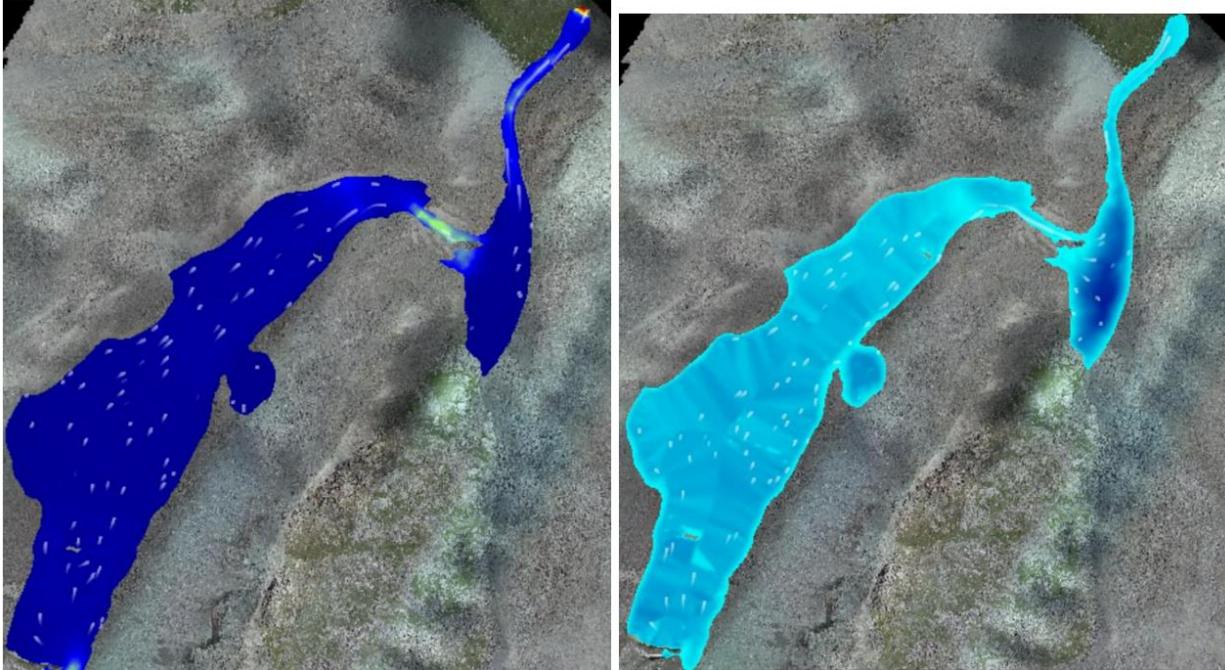
After 40 minutes:

4) *The water flow will proceed downstream into the river channel.*

Flow velocity in the main area decreases to 1.4 m/s with a depth of 1 m.

Inflow velocity from the depression reaches 4 m/s.

Total water surface area: 146,455.7 m².

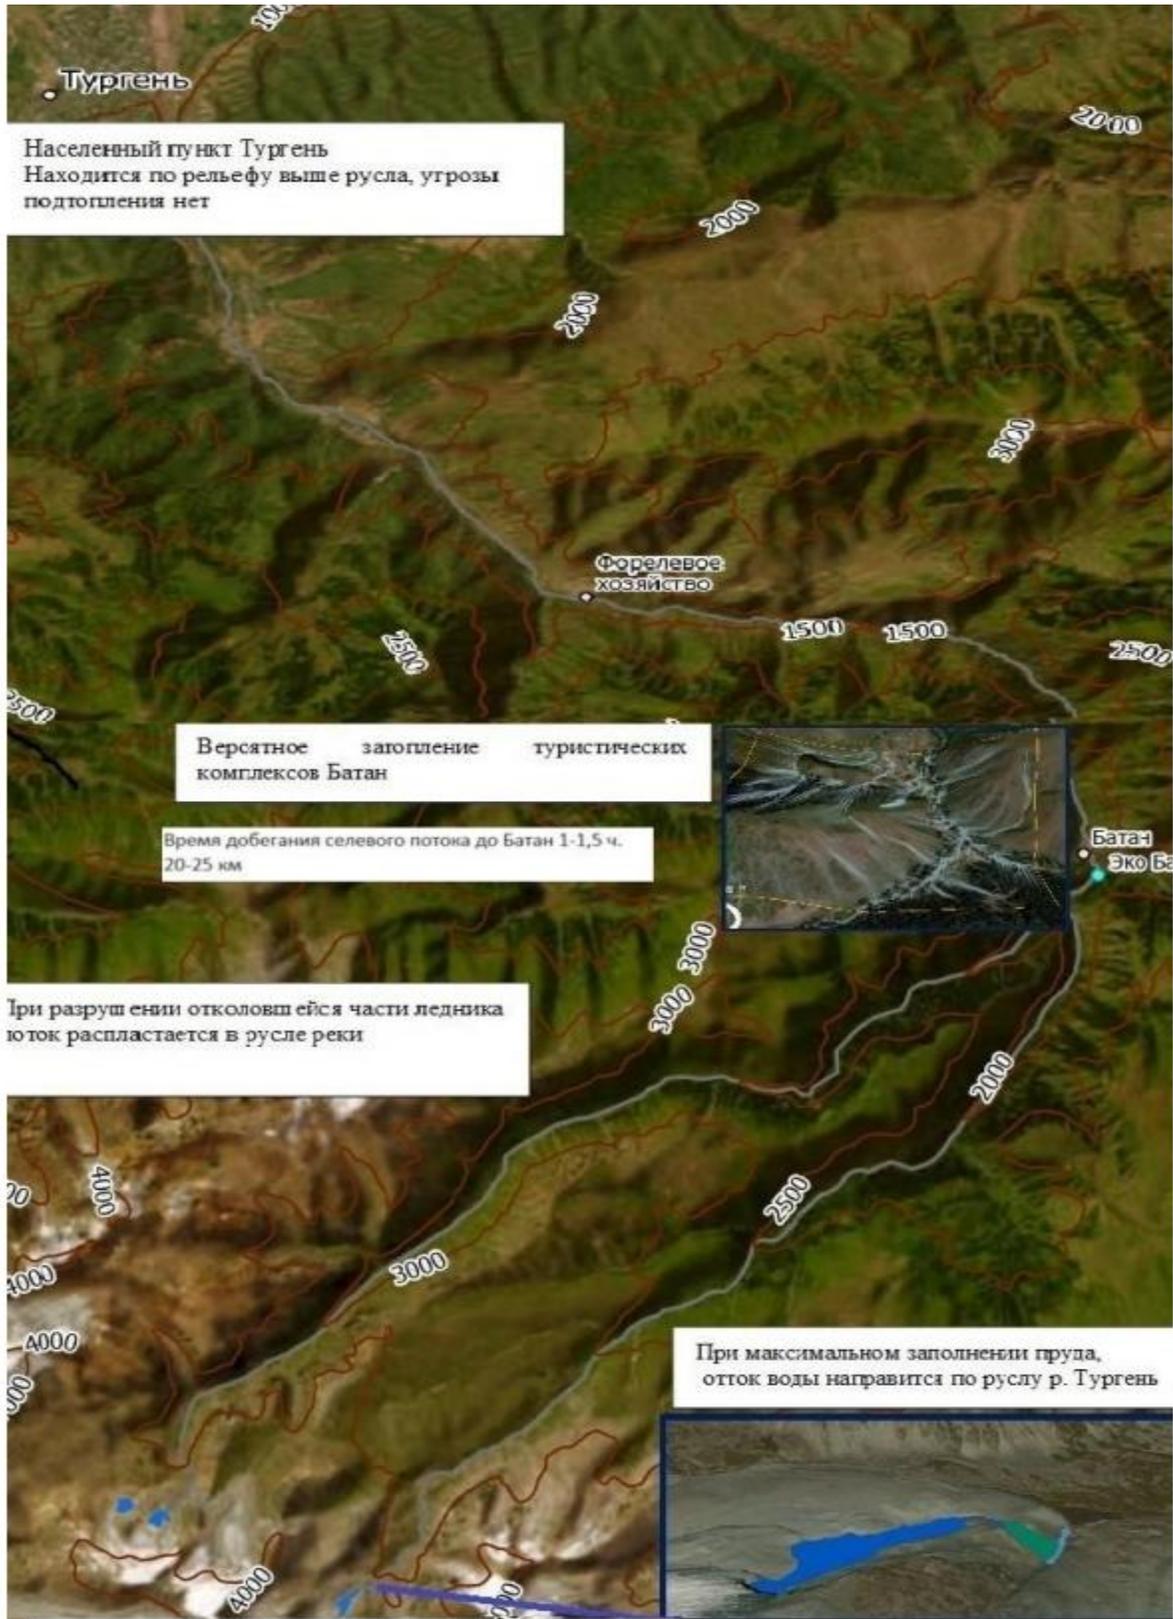
Probable direction of water flow from the lake along the river channels

Analysis of the current hydrological conditions in the area indicates that the risk of debris flow formation is minimal. The riverbed depth and natural barrier structures of the terrain help contain the flow, thereby reducing its kinetic energy and, consequently, the potential threat to the settlement of Turgen. Thus, the likely impact of a debris flow does not pose a significant hazard to this area.

Special attention should be given to the Boran tourist complex, which is located within the potential influence zone of a debris flow. However, based on current assessments, the likelihood of significant impact on this facility is presently low.

It is recommended to continue monitoring hydrological conditions and terrain status to ensure timely detection of any changes that may affect the risk level.
